Naumuk 6061-T6 Corrosion Problem

Sample: 6061-T6 sheet, 0.025"

Stored in dehumidified basement in contact with kraft paper on one side. I assume the sheet was in contact with a second sheet of aluminum on the rear side.

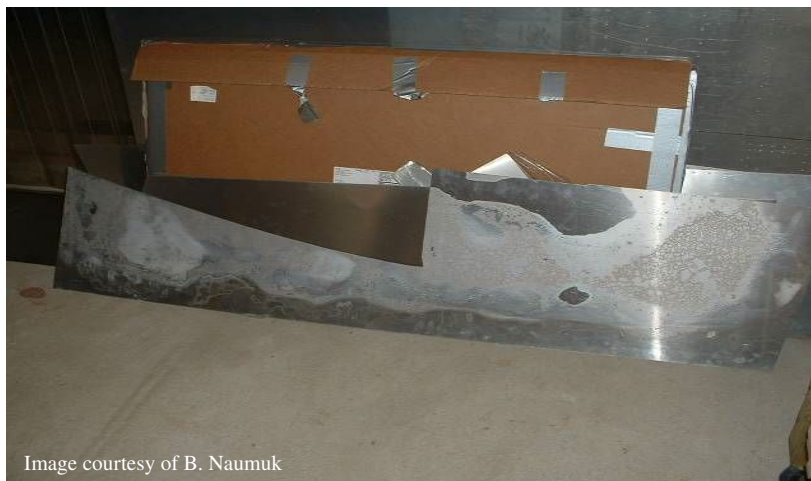
For all of you touting the corrosion resistant qualities of T-6, look at the attached picture. This is the only original skin I still have- I keep it around to make L angle out of. The T-6 picture was taken in the garanger, "Other stuff" was taken in the basement. Not exactly severe conditions.

My skins were stored standing upright against the panelled walls of my basement (Where a dehumidifier was running 24/7) in their paper wrapping. When was ready to install them, this is what I found when I unwrapped them. Consequently, I literally had to rebuild 75% of my factory supplied parts from scratch. And yes, the factory T-6 marks are on all the bad skins.

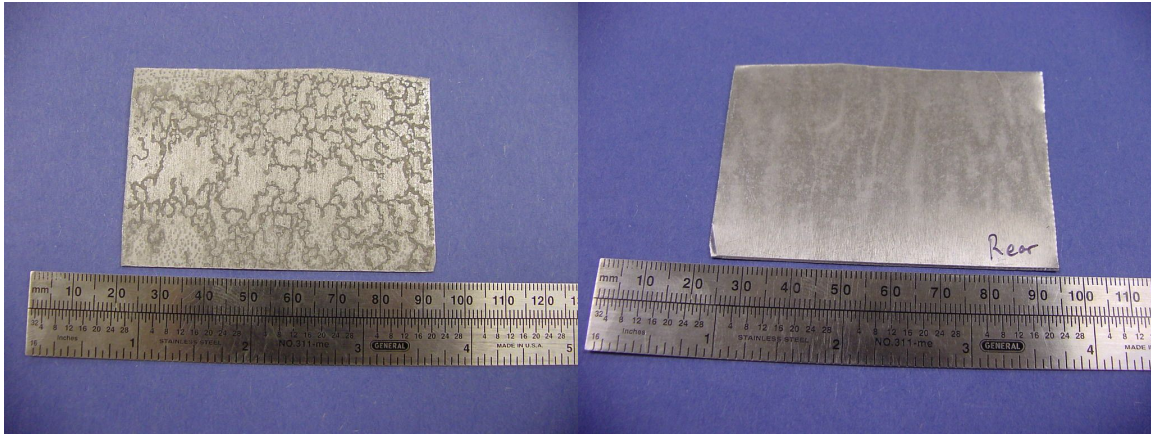
Figure 1: Front side: in contact with paper.

Rear side: in contact with aluminum sheet.

So what does this all mean? The general appearance of the corrosion does not follow traditional filiform attack or common pitting attack from a contaminant. The pattern of the corrosion seems to indicate that water or moisture played a significant role. Although the parts were stored in a dehumidified area, it's still possible that water came into contact with the sheets at some point. For example, if the parts were originally stored outside and were relatively cold, bringing them inside to a warm (and more humid) area could cause condensation to accumulate on the surface. Kraft paper can easily serve as a condensation point and initiate condensation when otherwise it may not occur. Or, the sheets could have been exposed to water / condensation during shipping.

Prevention of corrosion like this would hinge on eliminating humidity, temperature changes, and moisture. Separating individual sheets and increasing air circulation would help to eliminate the potential for condensation to occur in a crevice (between sheets). Taking sheets out of the kraft paper would eliminate sulfur from transferring to the aluminum if some moisture did form. In the extreme, one could apply Corrosion X or other spray inhibitors on the individual skins but in my opinion this is rather unnecessary if the skins are stored individually and with good air circulation.

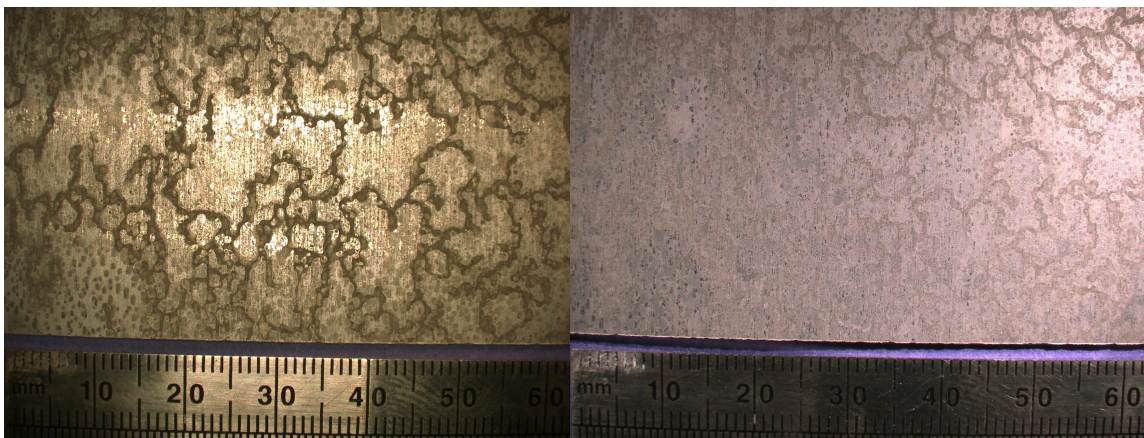
Figure 2: Close-up views of the front side with different lighting.

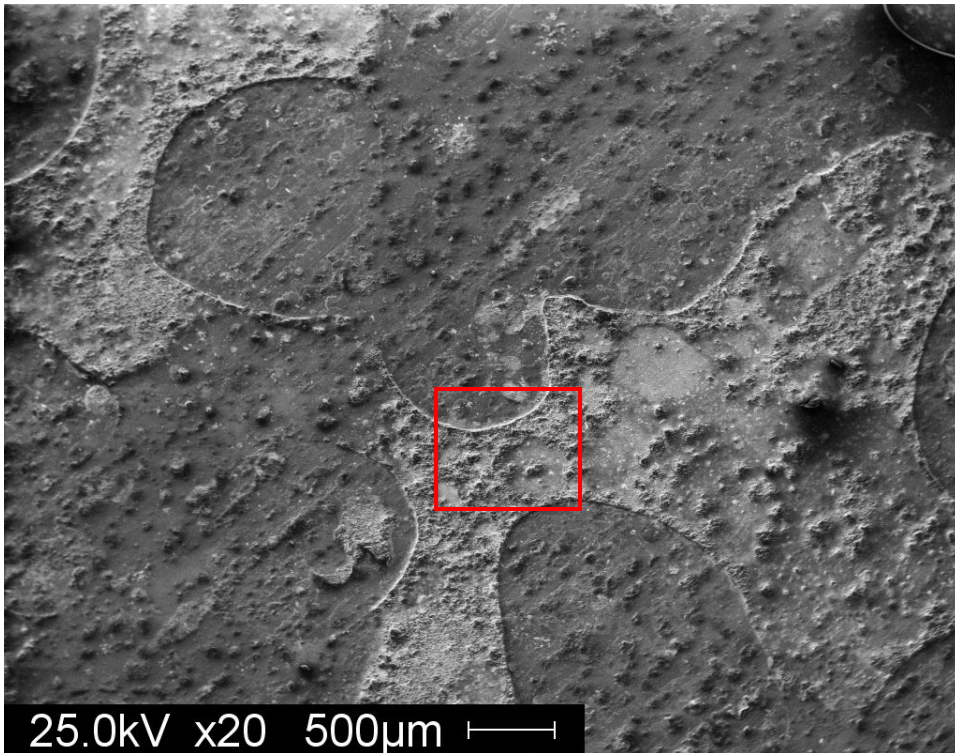
Figure 4: SEM view of the surface showing the areas of corrosion.

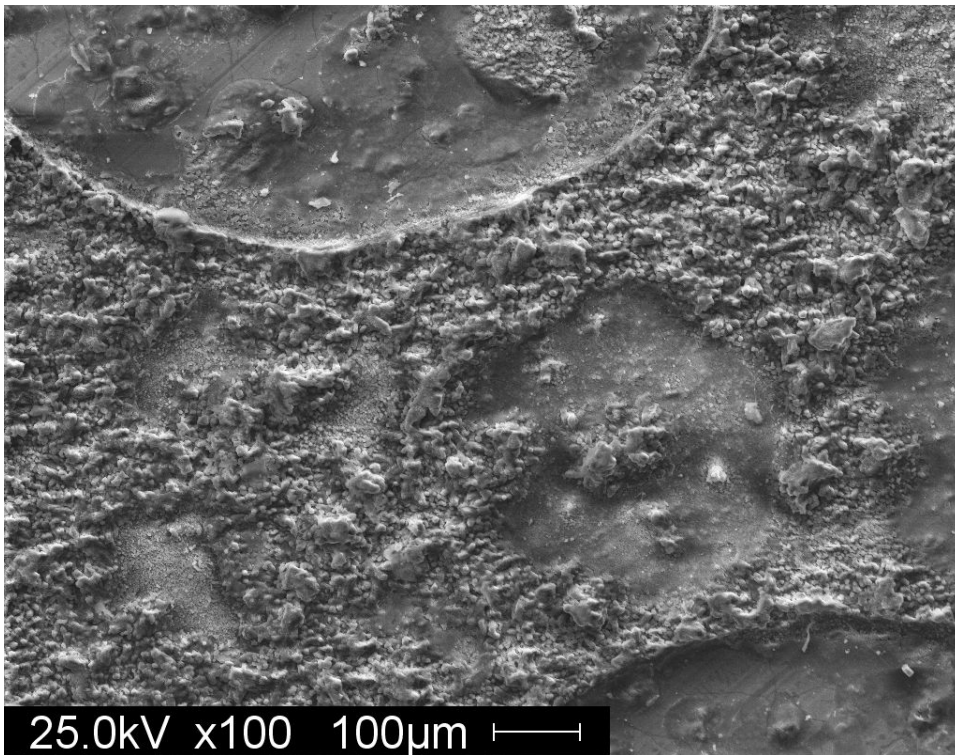
Figure 5: Enlarged view of the corrosion product shown in Figure 4.

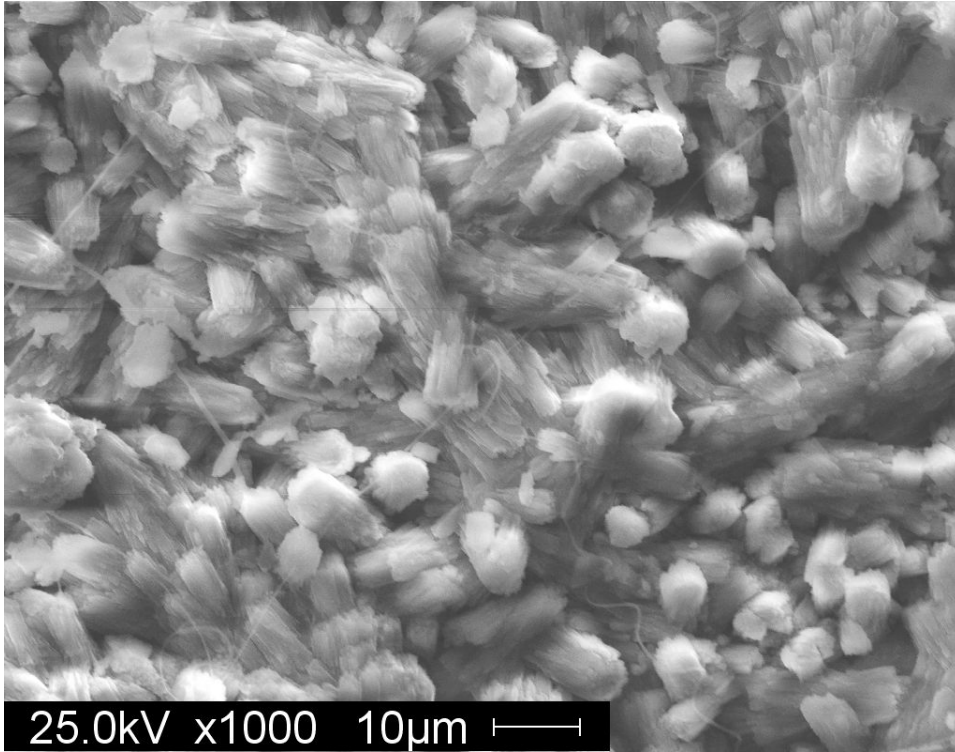
Figure 6: Corrosion product.

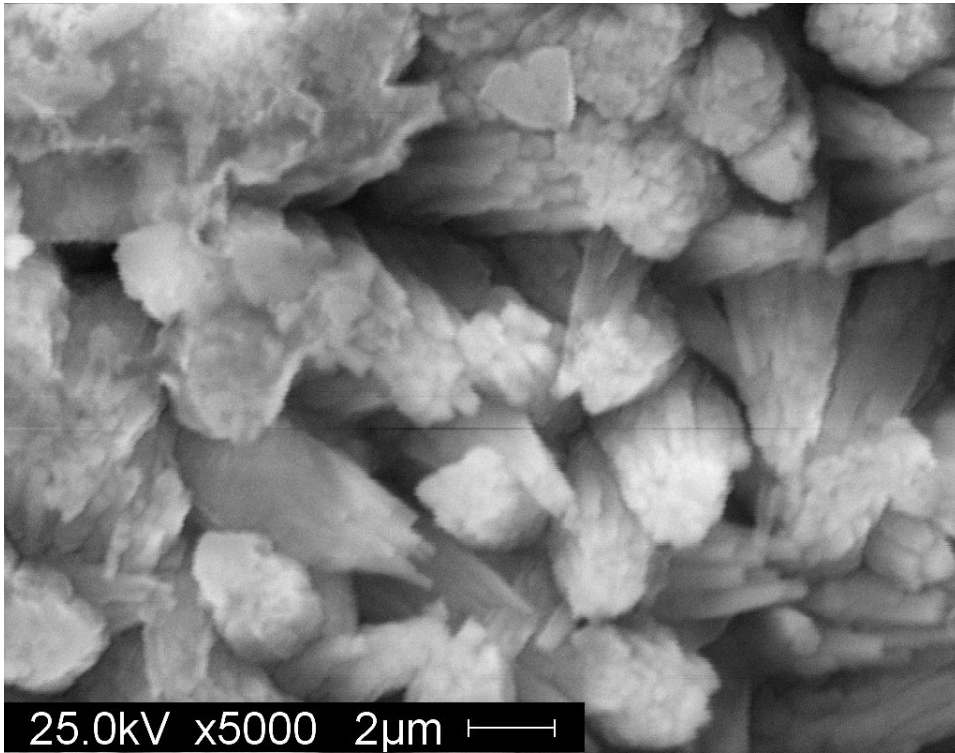
Figure 7: Close-up view of the corrosion product.

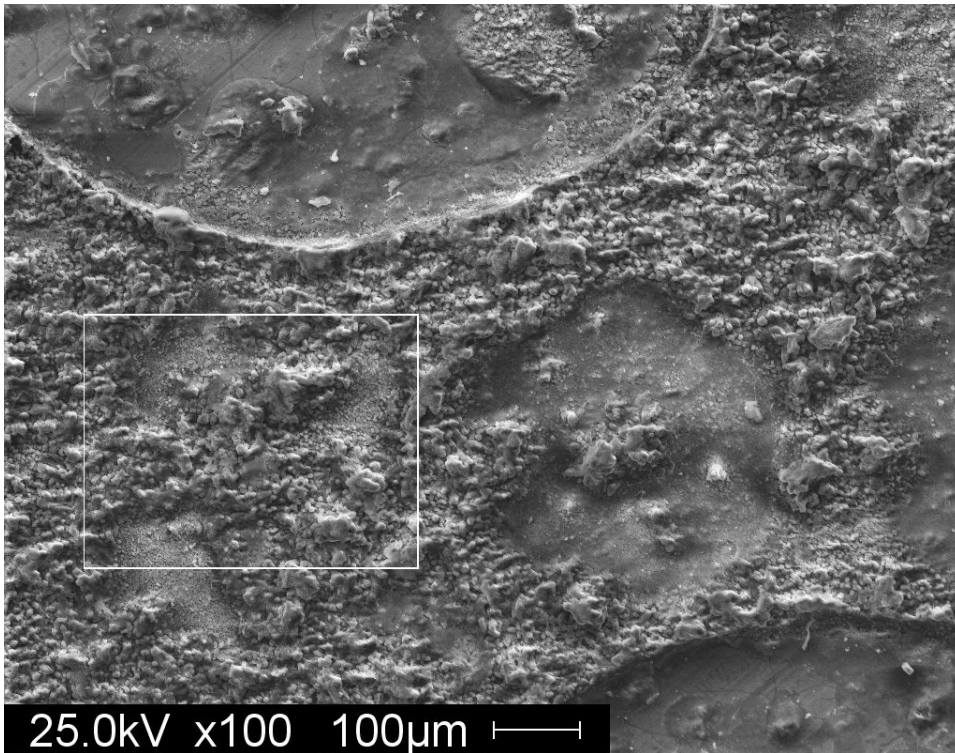
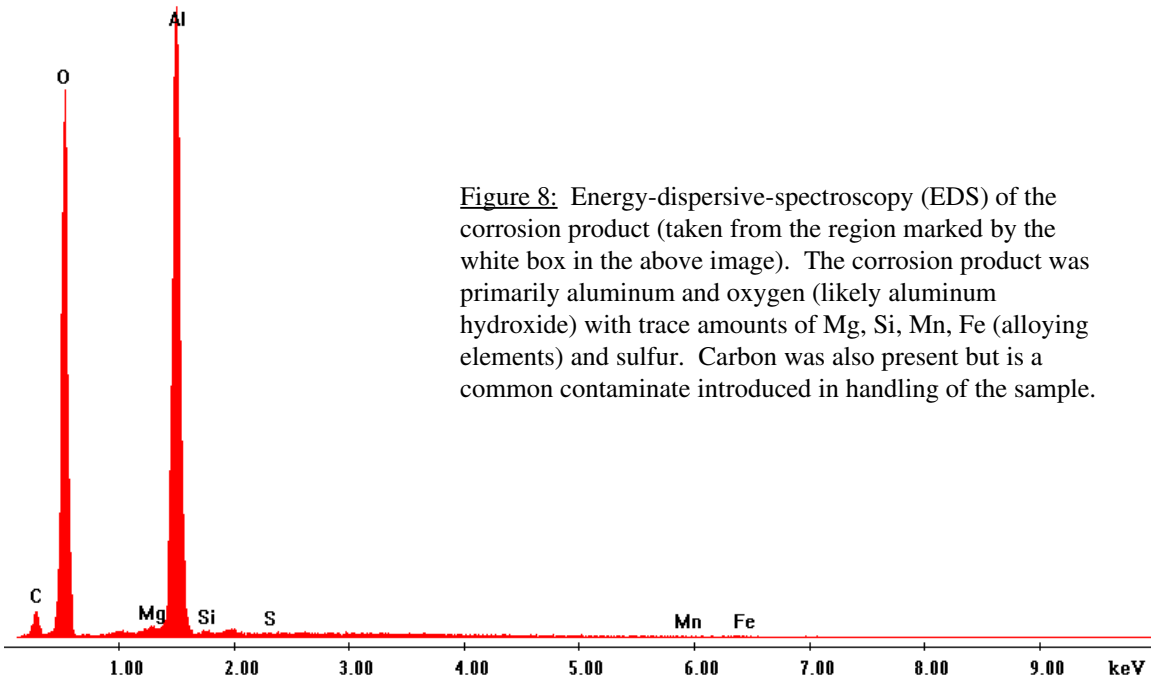
Figure 8: Energy-dispersive-spectroscopy (EDS) of the corrosion product (taken from the region marked by the white box in the above image). The corrosion product was primarily aluminum and oxygen (likely aluminum hydroxide) with trace amounts of Mg, Si, Mn, Fe (alloying elements) and sulfur. Carbon was also present but is a common contaminate introduced in handling of the sample.

The majority of the corrosion product was aluminum and oxygen. This is typical of corrosion that occurs in the presence of humidity or water. Unfortunately, the SEM can not detect hydrogen so I can't differentiate between aluminum oxide and aluminum hydroxide. But, based on my (limited) experience with other corrosion failures, I believe this to be a hydroxide which indicates moisture / water based attack. The fact the sheets were stored in a dehumidified area suggests that the initial exposure to moisture occurred prior to the sheets being stored. But, once the corrosion starts, it would continue (slowly) even when moved to the dehumidified area.

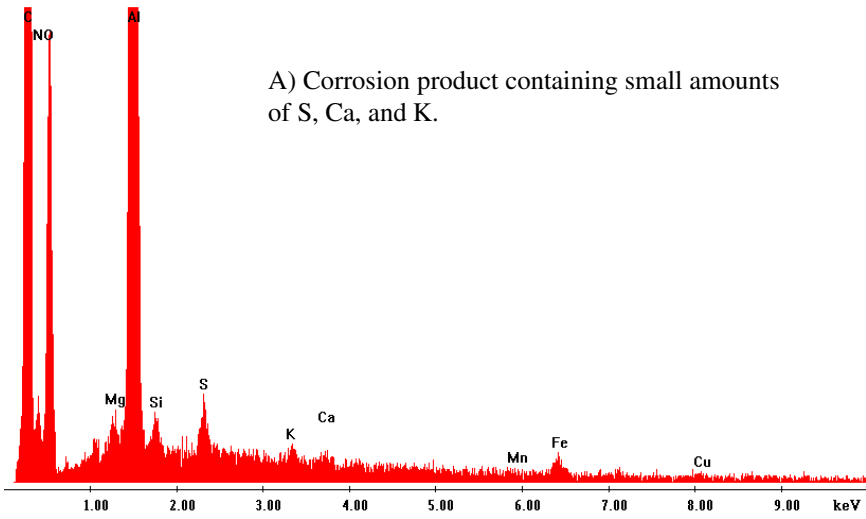
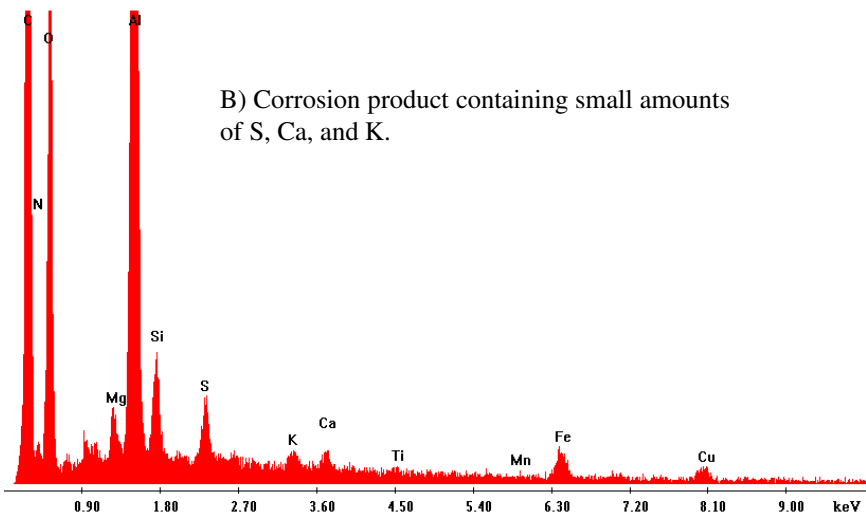
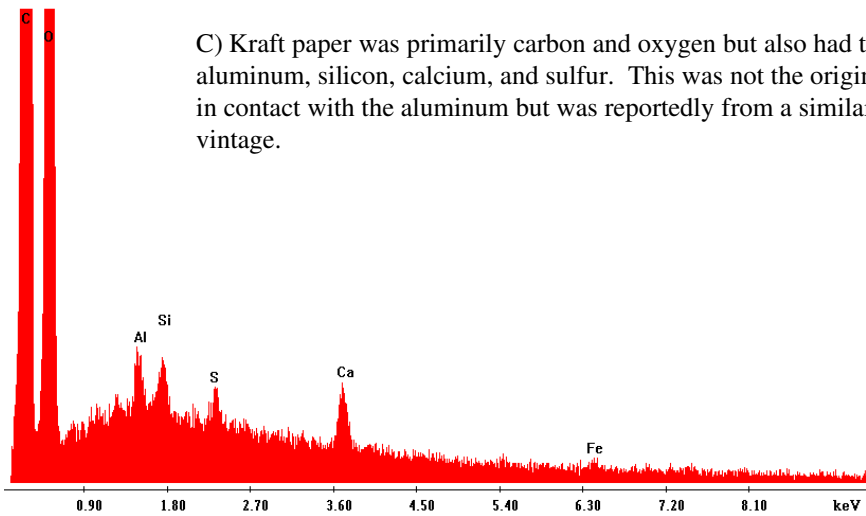
Figure 9: EDS patterns collected at several locations in the corrosion product. Some areas contained traces of sulfur, potassium, and calcium (in addition to the expected alloying ingredients).

A spectrum was collected from the kraft paper (bottom) which contained traces of calcium and sulfur.

The presence of sulfur and calcium in the corrosion product as well as the kraft paper suggests the two are connected. Calcium would not be detrimental to the aluminum but the sulfur does have the potential for initiating corrosion. That being said, water alone can cause problems if it accumulates in a crevice or other isolated location. The addition of sulfur would be an added accelerant. Chlorine was also found in the corrosion product and the source of that is not clear but could be from the use to cleaning products (laundry bleach, etc) nearby. The amount of chlorine was minor and only found in the cross-section so I think that was a minor factor. I did not find any significant amounts of other potential "bad actors" like particulates of copper, significant levels of chlorine / fluorine / nitrogen, particles of iron, etc. The source of potassium in the corrosion product is unclear.

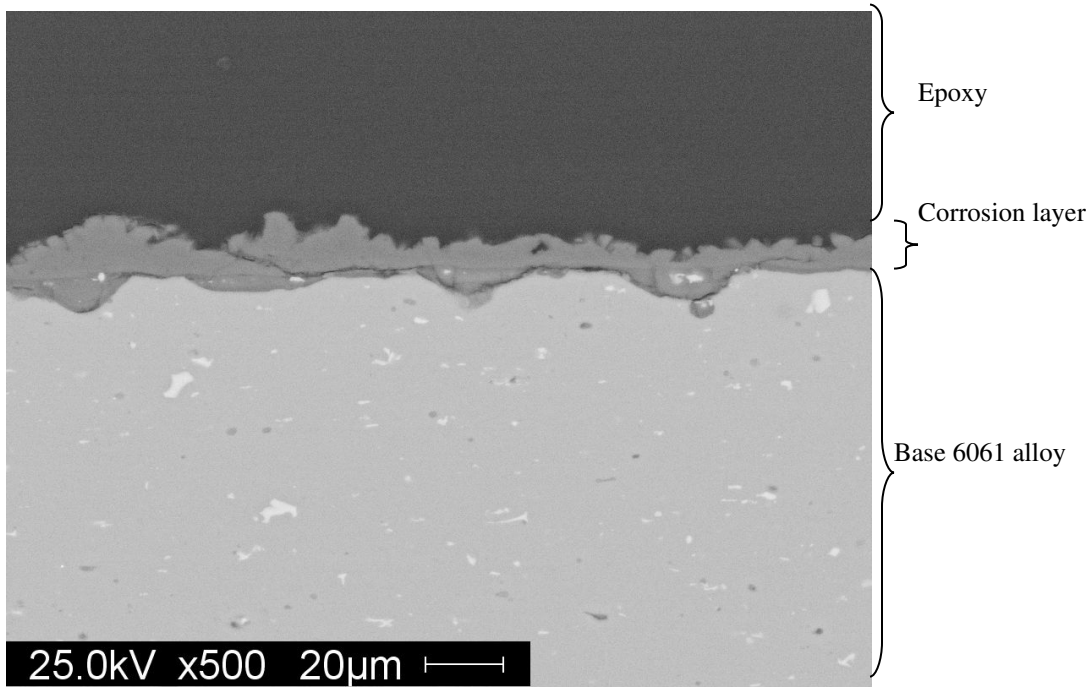
Figure 10: Cross-sectional view of the corrosion. Minor pitting extended ~10 microns into the aluminum. This image shows the most severe pitting / corrosion in the cross-section removed from the coupon. However, only one cross-section was taken and so it's likely that more severe attack could be found at other locations.

Use of skins showing this type of corrosion should be avoided in structural applications subjected to fatigue. The pits that formed only penetrated about 10 microns (~0.0005 inches, or ~2% of the sheet thickness). This would not significantly reduce the load capacity of the sheet but could a) reduce ductility / elongation or b) act as a crack nucleation site for fatigue. I would not hesitate to use the sheet in non-structural applications. If the corrosion was removed and the surface sanded, I would consider using the material for reinforcements (like standard L's) with the understanding that the thickness of the sheet has been reduced.

For cleaning of skins such as this, I would use a combination of wet-sanding with 600 grit SiC paper followed by alumiprep / maroon scotchbrite. SiC paper can cause corrosion of the aluminum – which is why I would follow the SiC paper with the alumiprep and scotchbrite which would loosen and remove any residual SiC particles that became embedded in the aluminum.

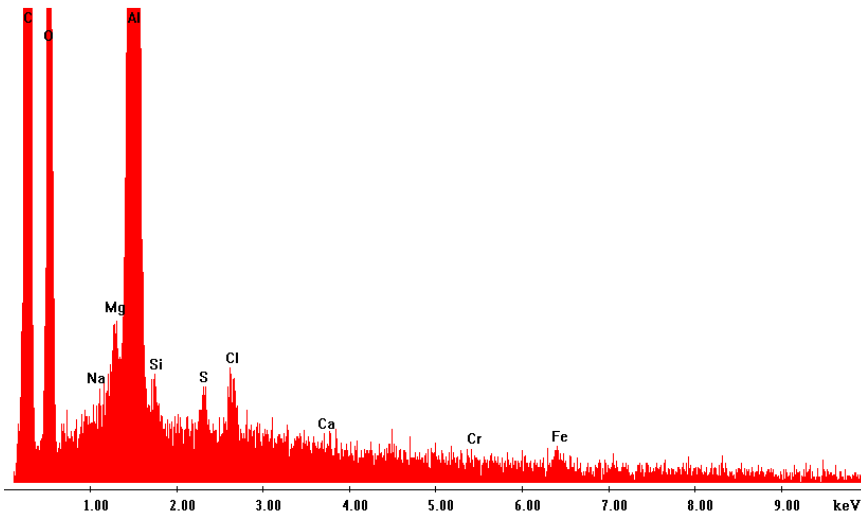
Figure 11: EDS spectrum taken from the corrosion layer shown above. Note the presence of sulfur and chlorine. Chromium and sodium, although labeled, were not present to any significant amount.
