AVIAD AIRCRAFT INC

SERVICE LETTER

SUBJECT: Possible damage to turtle deck.

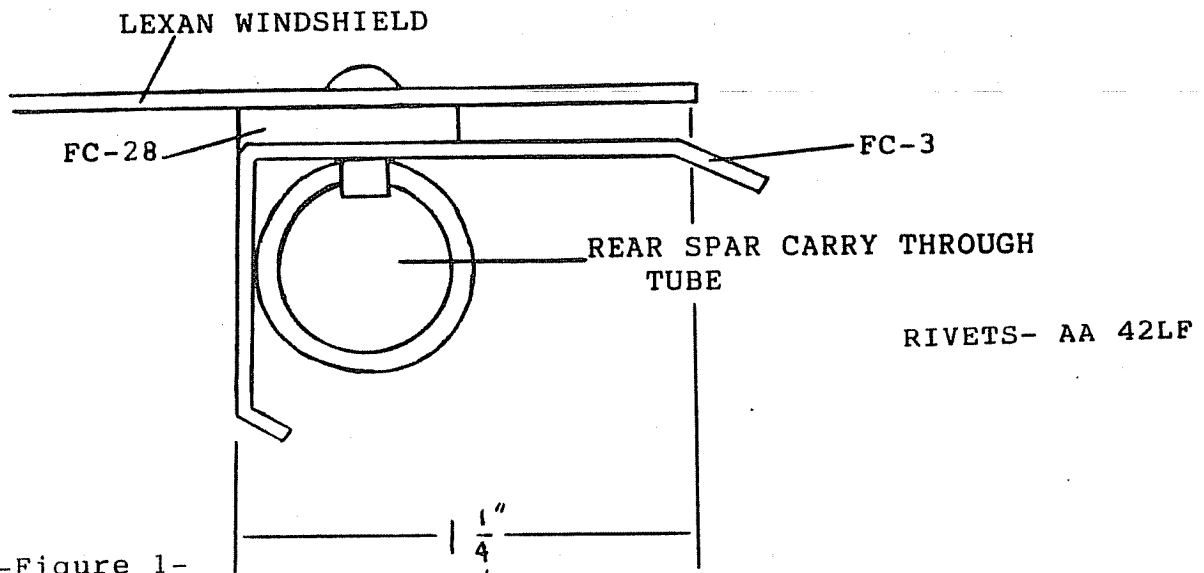
-Figure 1-

To ensure proper engagement of the turtle deck leading edge under the Lexan skylight, see that a minimum of 1 1/4" of skylight extends off as measured from the front edge at FC 3 to the rear edge of the Lexan.

ACTION: If you have not yet installed your skylight, refer to figure 1. Note, the edge distance on the skylight must be at least 1 1/4".

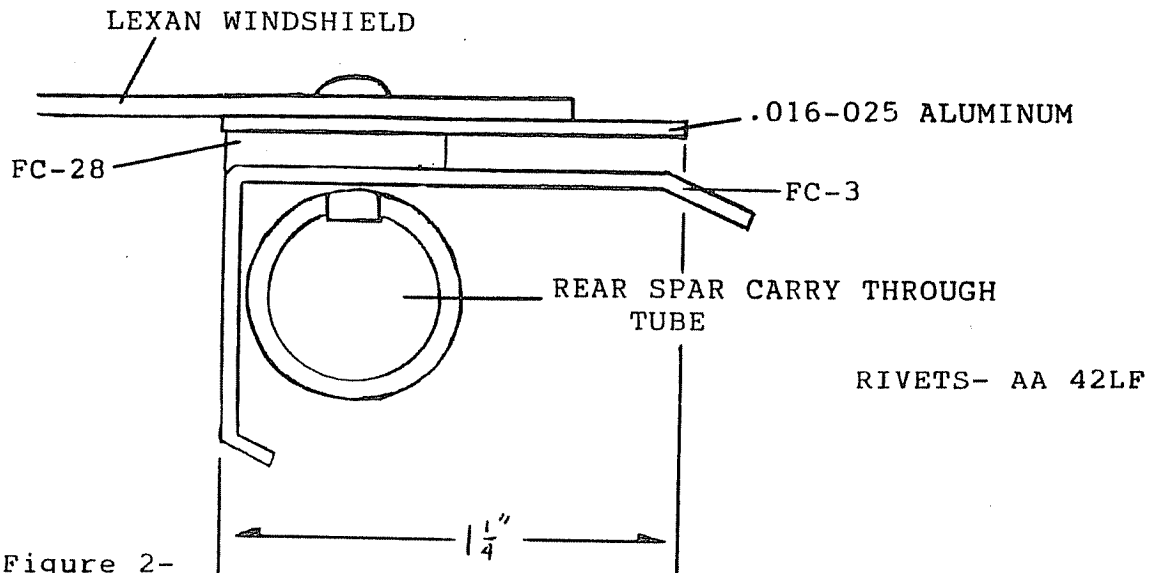
If your skylight has been installed, check to see that the minimum edge distance requirement has been met. If after inspection it is determined that you have inadequate edge distance, refer to Figure 2.

- A. Remove rivets attaching the Lexan to the rear spar carry through tube.
- B. Install an aluminum strip .016-025-thick, between PN FC-28 and the Lexan windshield ensuring a minimum of 1 1/4" length as measured from the front edge of FC 3 to the rear most edge of the aluminum strip.
- C. Install rivets, check turtle deck fit.
