SERVICE LETTER

SUBJECT: Possible damage to turtle deck.

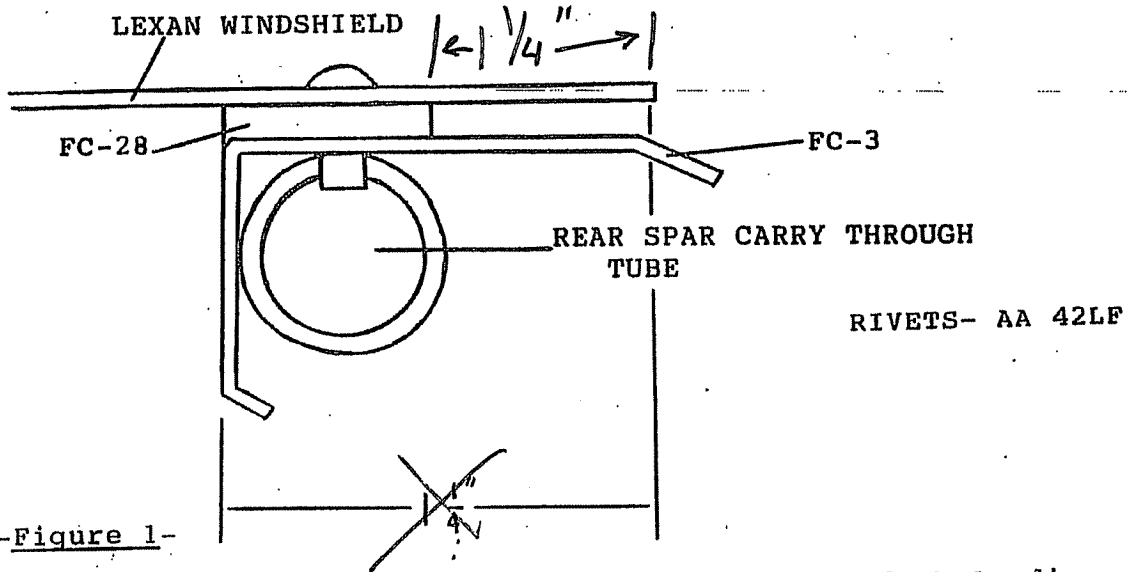
-Figure 1-

EXPLANATION: It has come to our attention that some builders are not providing adequate edge distance at the rear most edge of the Lexan skylight. The leading edge of the turtle deck must engage the skylight with a minimum overlap of 1 1/4".

To ensure proper engagement of the turtle deck leading edge under the Lexan skylight, see that a minimum of 1 1/4" of skylight extends off as measured from the ~~front edge~~ **BACK EDGE** of FC-3 to the rear edge of the Lexan. **OF FC-28**

ACTION: If you have not yet installed your skylight, refer to figure 1. Note, the edge distance on the skylight must be at least 1 1/4".

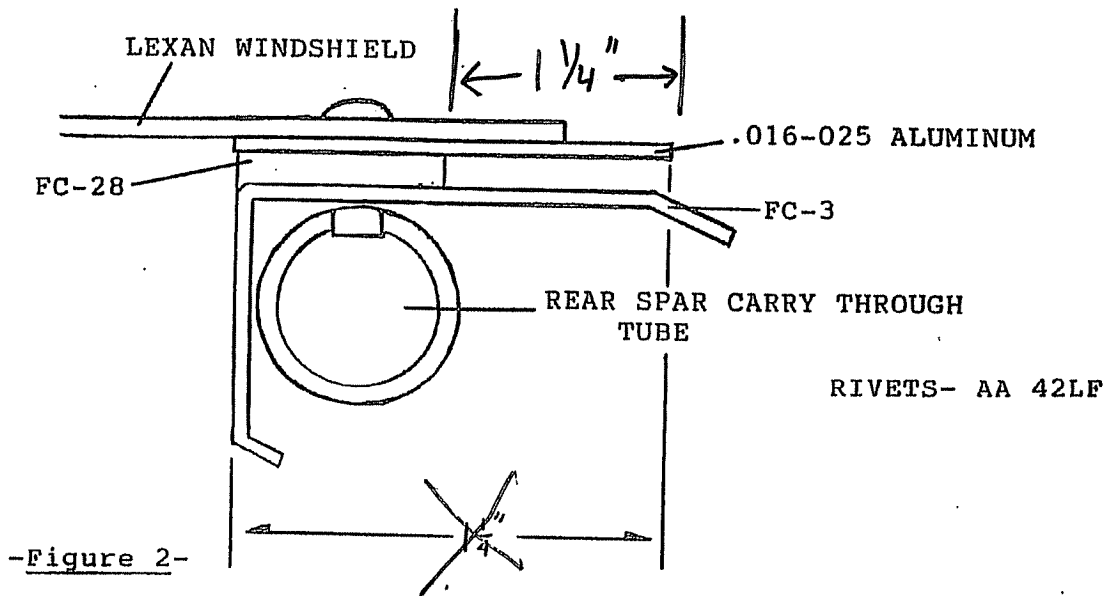
If your skylight has been installed, check to see that the minimum edge distance requirement has been met. If after inspection it is determined that you have inadequate edge distance, refer to Figure 2.

- A. Remove rivets attaching the Lexan to the rear spar carry through tube.
- B. Install an aluminum strip .016-025-thick, between PN FC-28 and the Lexan windshield ensuring a minimum of 1 1/4" length as measured ~~from the front edge of FC 3 to the rear most edge of the aluminum strip.~~
- C. Install rivets, check turtle deck fit.
