An Investigation on Three Jabiru 2200 Fly Wheel Attachments.

Anton Lawrence 3/12/2006

On the 3rd December 2006 three Jabiru 2200 engines had their flywheel bolts replaced and re-torqued, the following shows the process and findings.

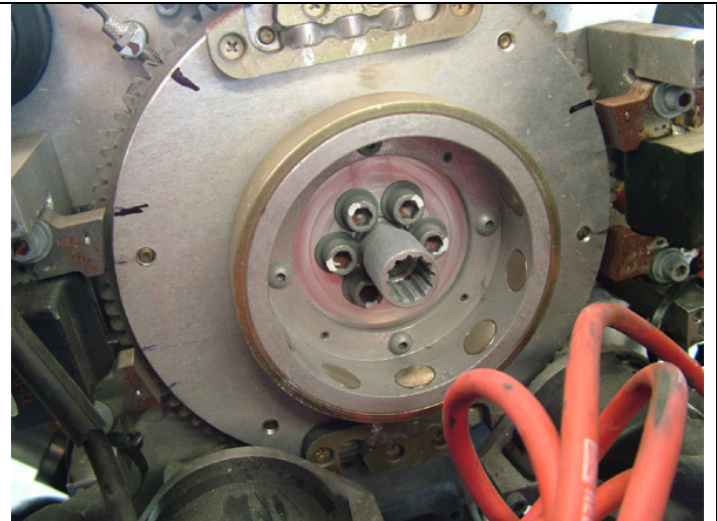
This is engine number 1677 but is the same as number 794. It was decided to remove and inspect the flywheel and vacuum drive. The black registration marks were added to ensure the ignition timing wasn't lost.

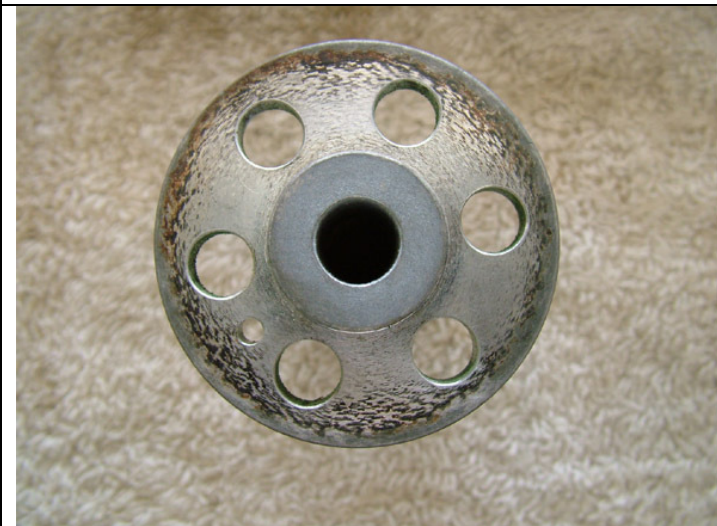
This is the back side of the vacuum drive it is pressed against the timing gear. The fretting is very obvious.

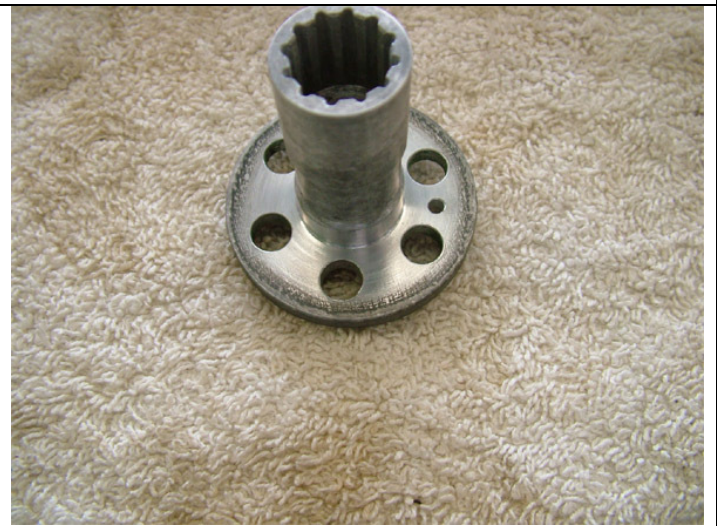
This is the side which presses against the back of the flywheel; there is a ring of fretting here also.

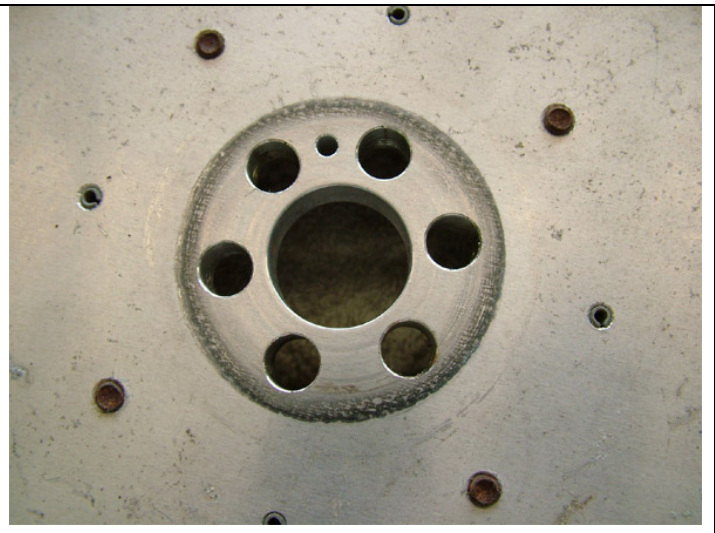
The back side of the flywheel, light fretting is obvious.

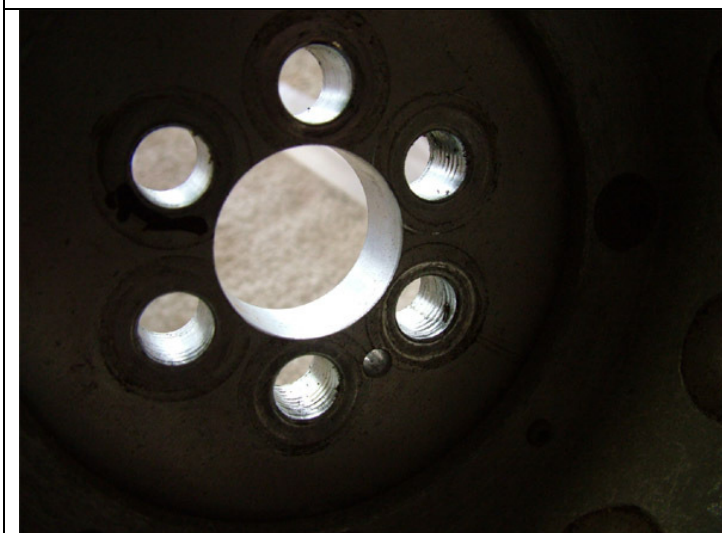
Thread marks are visible in the flywheel holes consistent with fretting. All three flywheels had these imprints.

It would also be fair to conclude that the higher the preload on the bolts the less the fretting.

New bolts were cut and fitted and the engine reassembled.

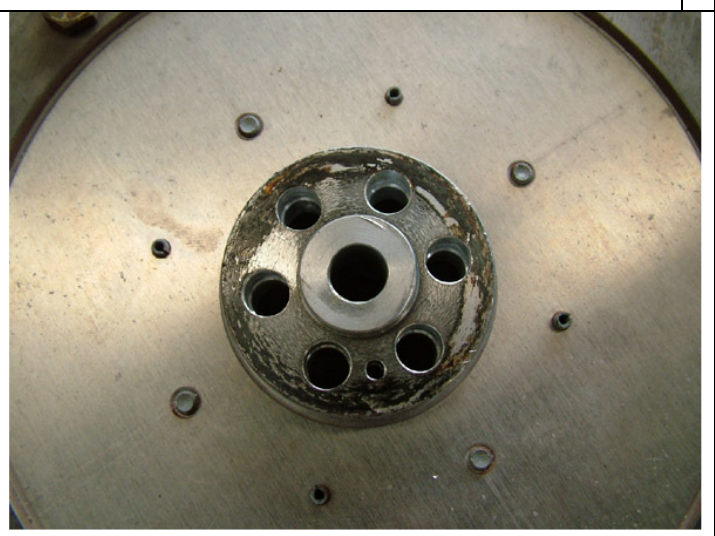
The vacuum drive was very heavily fretted on the back face.

Engine one clearly had less bolt torque than the other two engines, none the less engine two showed greater signs of fretting. Engine twos hours are similar to engine threes but engine three showed the least fretting.

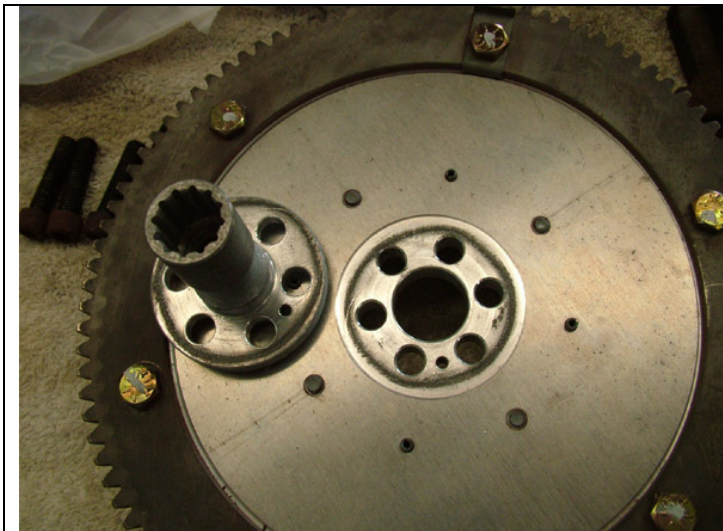
The back of the flywheel and the front of the vacuum drive also showed signs of fretting.

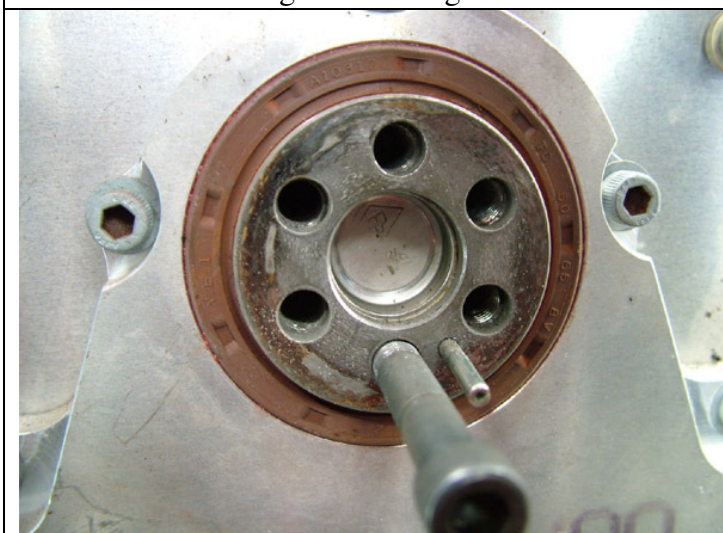
This is the part of the timing gear which protrudes the crankcase. The roll pin was factory fitted to assist in alignment. The bolt is a new one being used to clean the threads. Fret marks are clear.

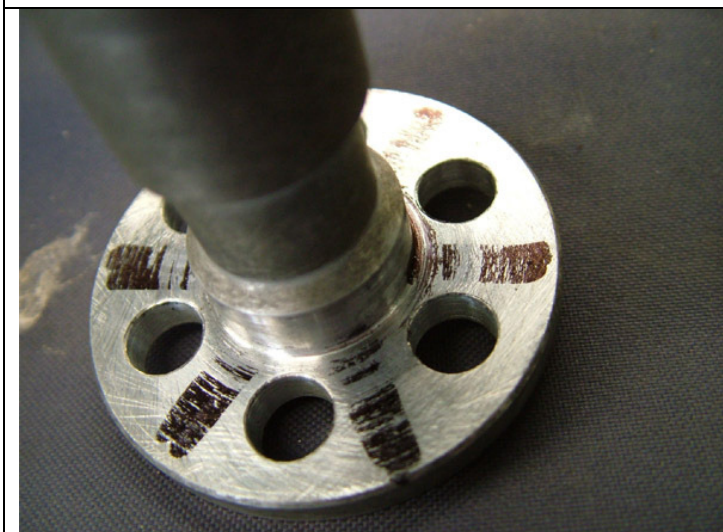
The Vacuum drive interfered with the flywheel at the internal radius. The flywheel had more chamfer removed to prevent this interference, sorry no picture.

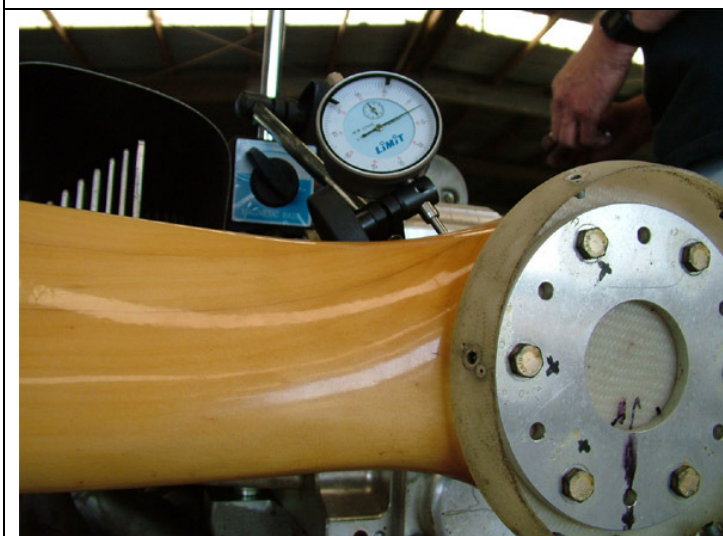
A dial gauge was used to check the prop flange run out.

Engine 1, 0.06mm and 2mm respectively.

Engine 2, 0.06mm and 2mm respectively.

Engine 3, 0.2mm and 0mm respectively.

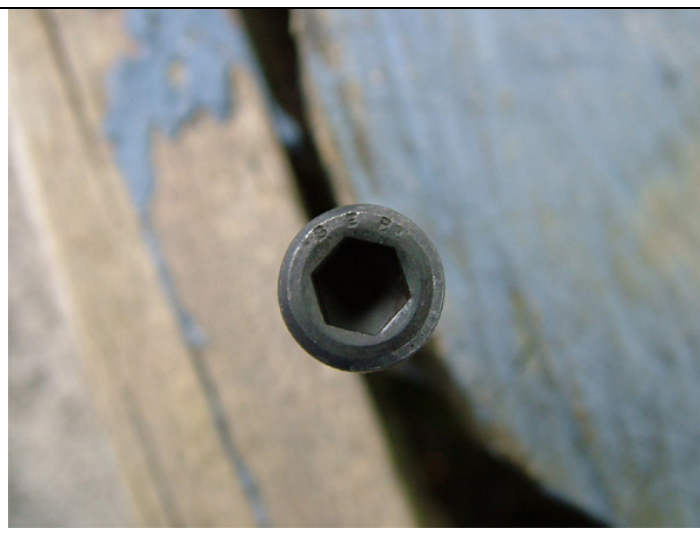
SEP Cap Screw

Why the difference? The Umbrako and Brighton Best YFS brands are made to the 1960 specification and SEP to an older specification; this is because a lot of machinery requires the smaller head cap screw, the material is none the less of a high standard.

DON'T USE SEP CAP SCREWS OR ANY OTHER WITH THE SMALL HEAD DIAMETER.
