# SOUTH AFRICAN CIVIL AVIATION AUTHORITY

## ACCIDENT REPORT – EXECUTIVE SUMMARY

# AIRCRAFT ACCIDENT REPORT

**Name of Owner/Operator** : Sweidan G.  
**Manufacturer** : Interavia  
**Model** : I-3  
**Nationality** : South African  
**Registration Marks** : ZU-PHA  
**Place** : Vergelegen Estate, Somerset West  
**Date** : 5 April 2005  
**Time** : 1210Z

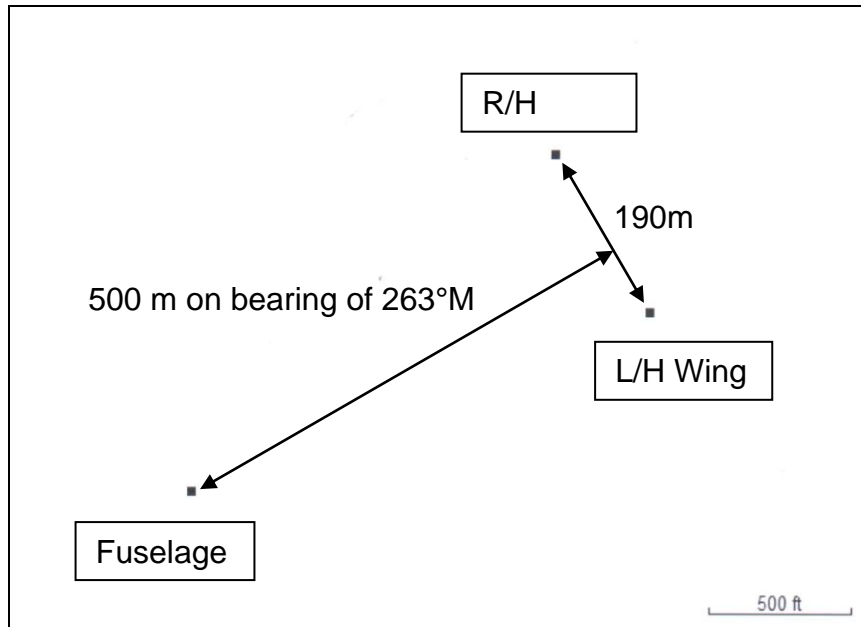
1.12.1 The wings of the aircraft had failed in flight and separated into two pieces, which were located approximately 190 m apart and approximately 500 m from the fuselage. The GPS coordinates of the wings and fuselage were as follows:

1.12.2 The diagram below shows where the three main sections of the aircraft fell:

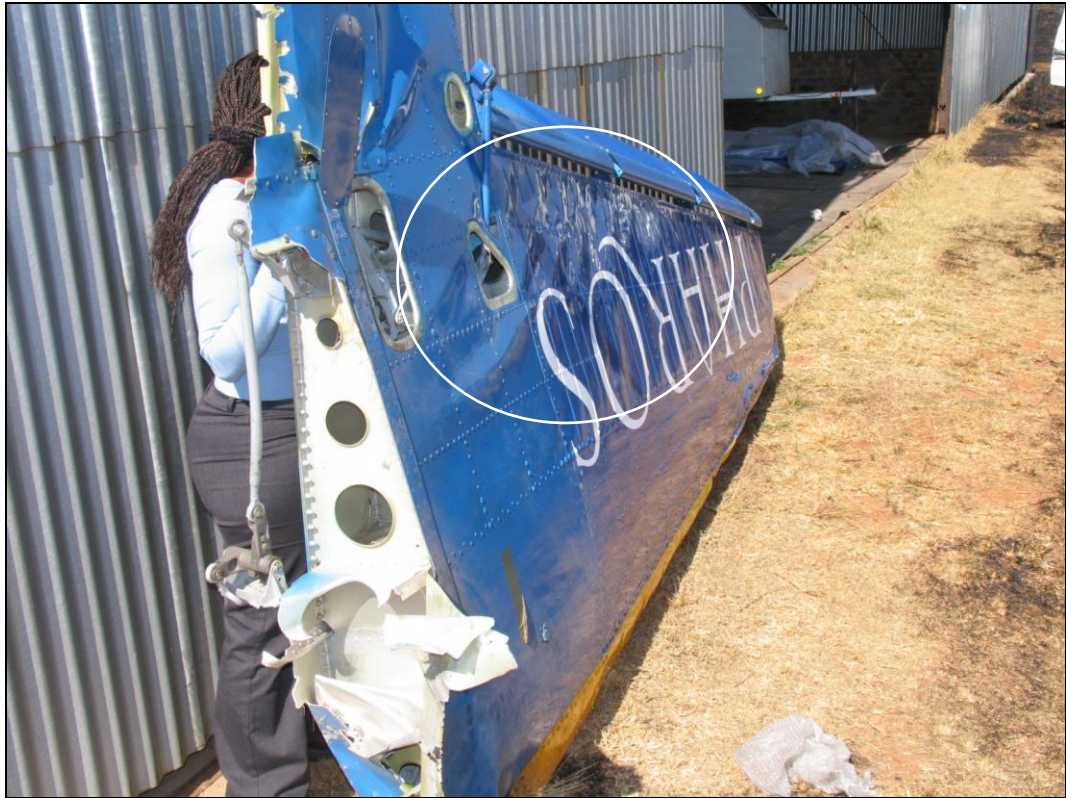
- 1.12.3.1 Close inspection of the bottom surface of the right wing showed evidence of compression buckles with an orientation from leading edge root to trailing edge tip. See photograph below.

- 2.9 The compression buckles on the lower surface of the right wing were orientated from the root leading edge to the tip trailing edge, which suggest a leading-edge-down / trailing-edge-up torsion moment, which is opposite to the indications on the left-hand wing.

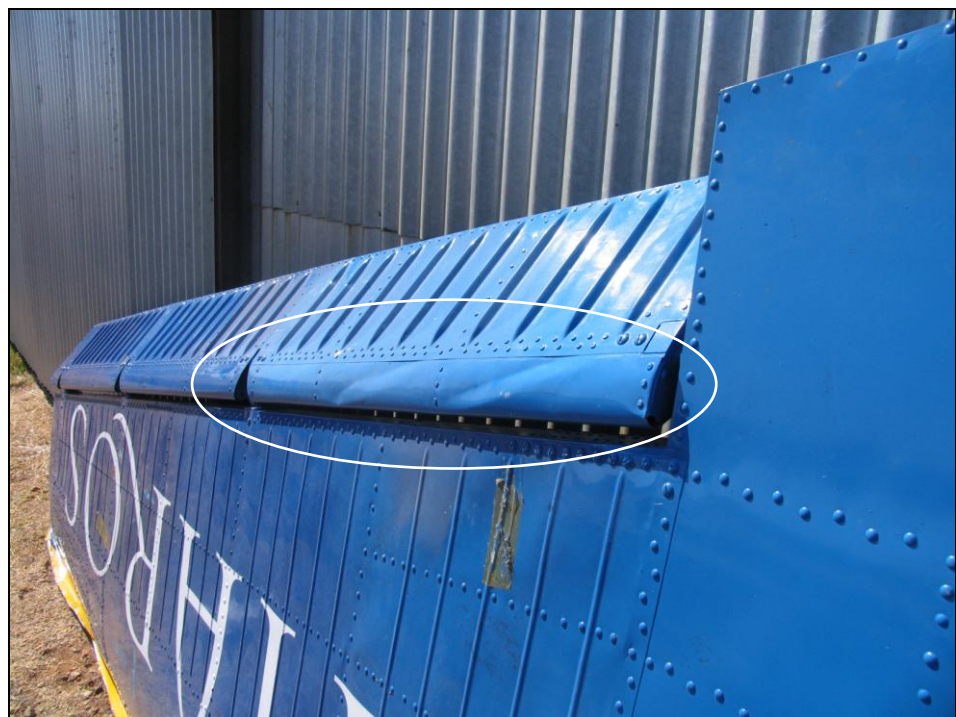
1.12.3.2 Right aileron: the upper surface leading edge of the aileron had two well-defined compression buckles in the root area, as can be seen below.

- 2.10 The compression buckles on the upper surface of the aileron leading edge of the right wing suggest an upward twisting moment on the aileron, with the control rod restraining the twisting moment, similar to but not as severe as that found on the left aileron.

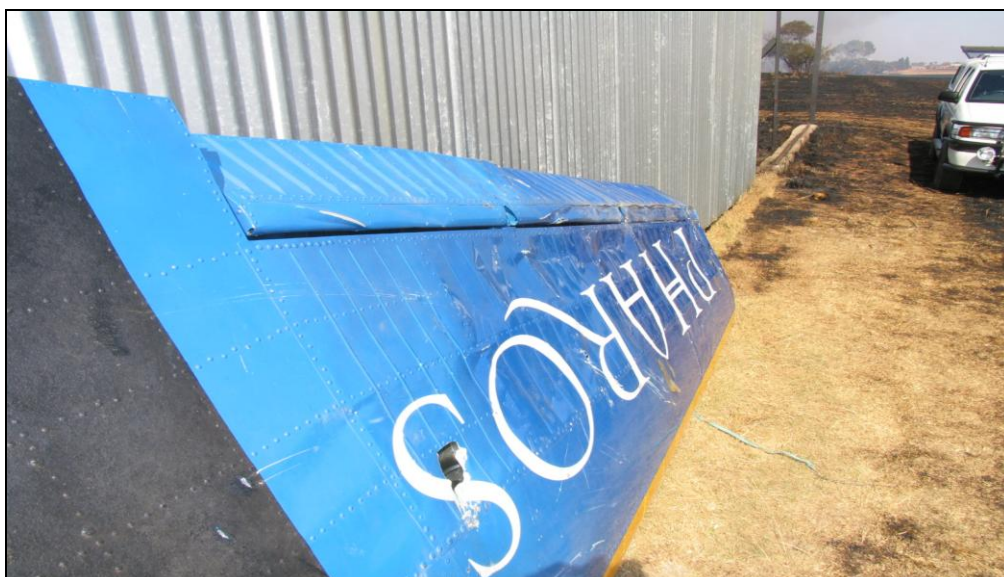
1.12.4.1 Close inspection of the left wing revealed compression buckles on the upper surface running from the leading edge root to the trailing edge tip as shown below.

- 2.5 The left wing upper surface showed evidence of compression buckles with an orientation from the root leading edge to the tip trailing edge. The bottom surface of the same wing also had compression buckles with an opposite orientation – from root trailing edge to tip leading edge.

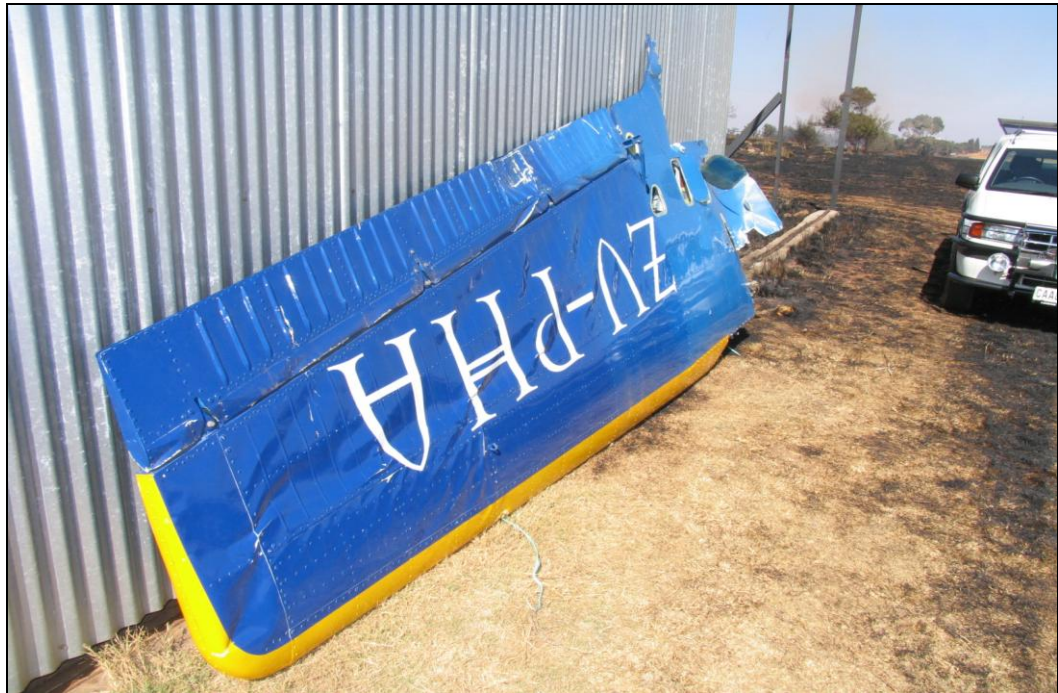
1.12.4.2 Compression buckles on the lower surface run in the opposite direction – from the trailing edge root to the leading edge tip area – as shown below:

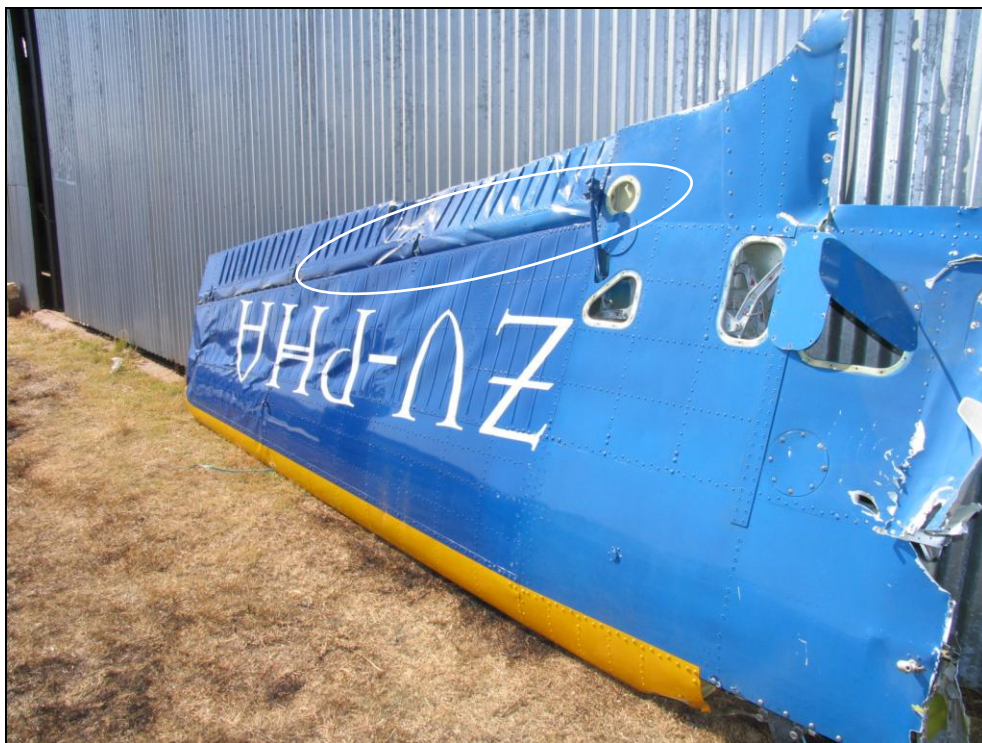
1.12.4.3 The leading edge of the bottom surface of the left aileron is shown below with several compression buckles evident along the leading edge of the aileron:

- 2.6 This deformation of the wing structure is typical of a leading-edge-up / trailing-edge-down twisting moment on the wing.
- 2.7 Examination of the left aileron also revealed significant distortion of the aileron leading edge, with various compression buckles present on its leading edge. The compression buckles on the bottom surface of the aileron are believed to have resulted from excessive upward twist of the aileron and with the aileron push rod offering the only restraint to the aileron twisting moment.

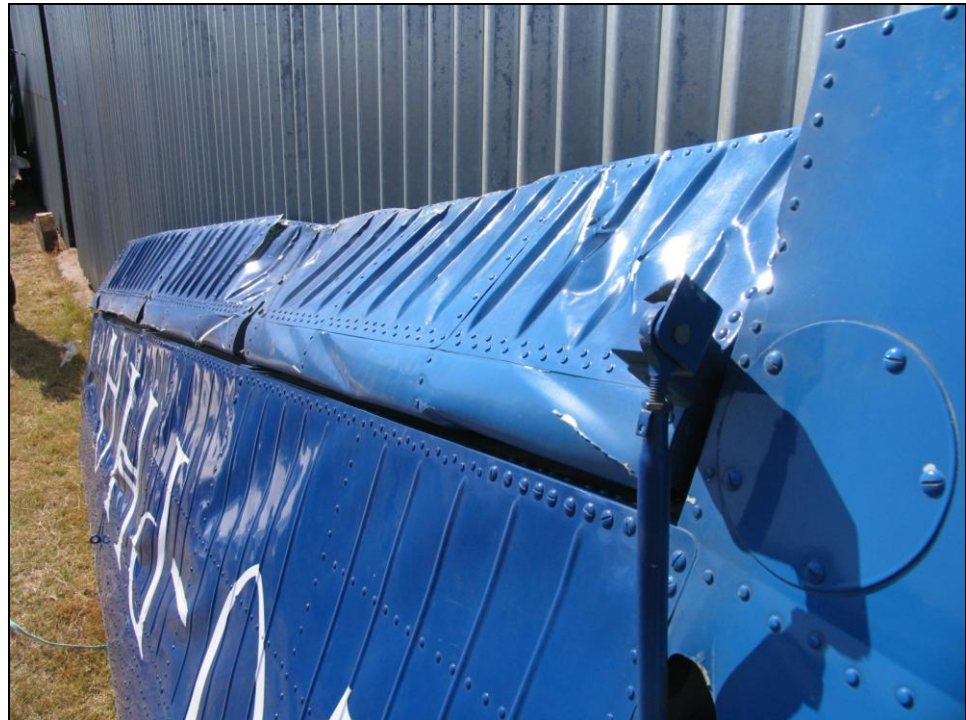
- 1.12.4.4 A closer view of the leading edge of the bottom surface of the left aileron is shown below.

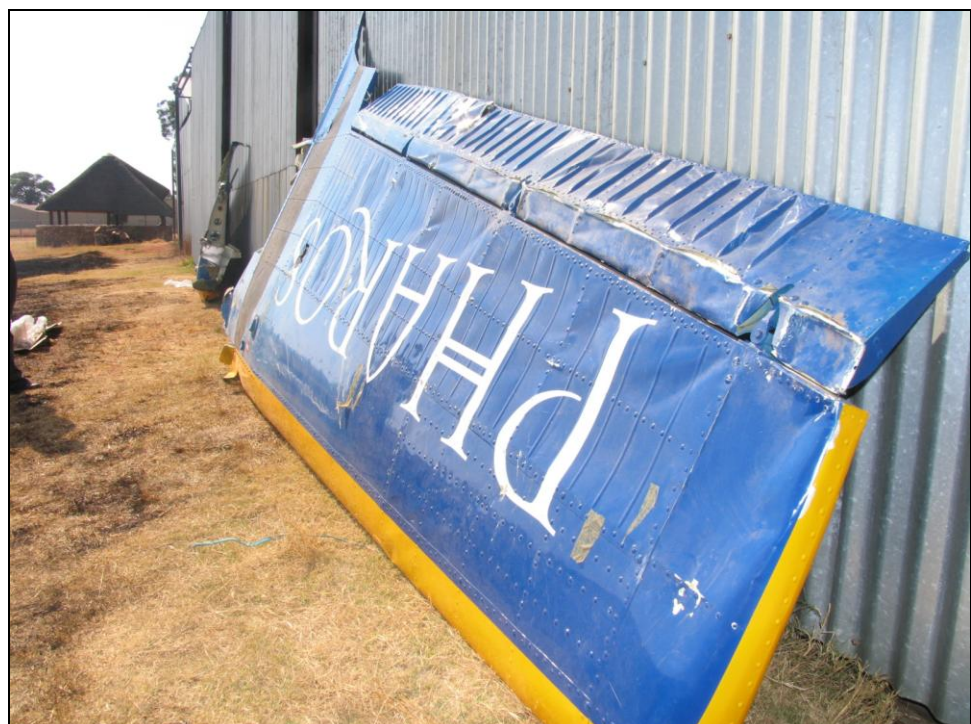
- 1.12.4.5 The leading edge of the upper surface of the left aileron is shown below. Significant compression damage is evident towards the tip of the wing.

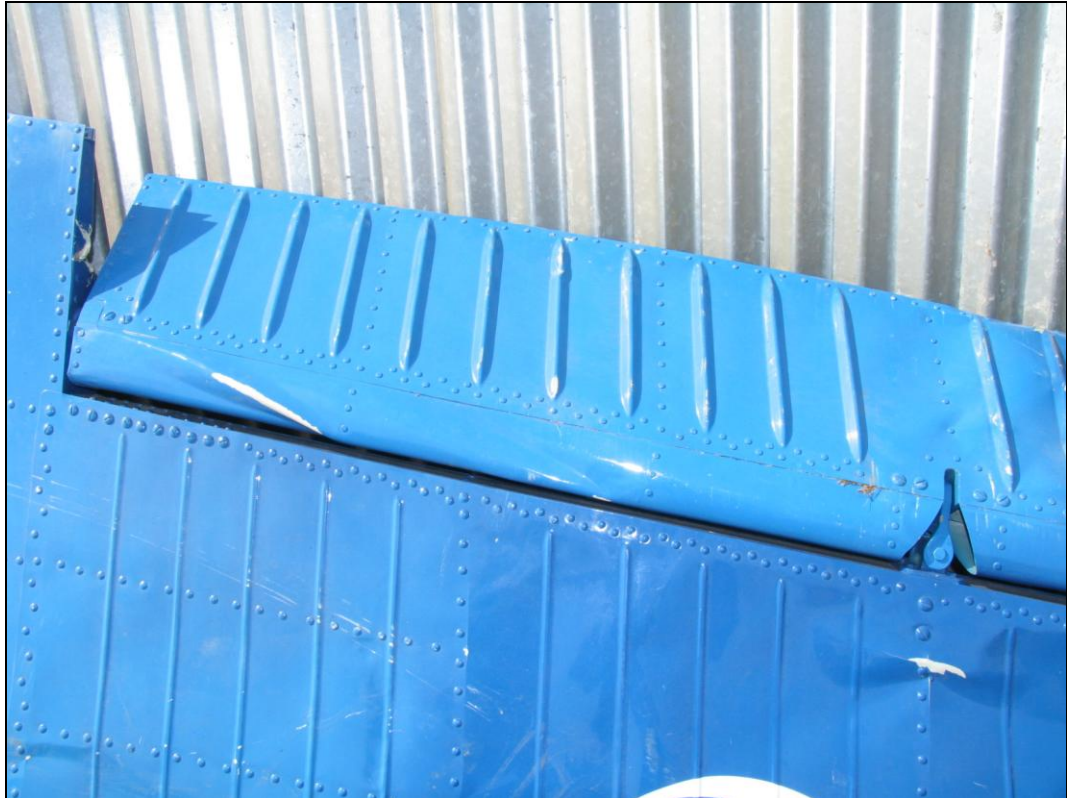
1.12.4.8 A close-up of the upper surface leading edge of the left aileron root area:

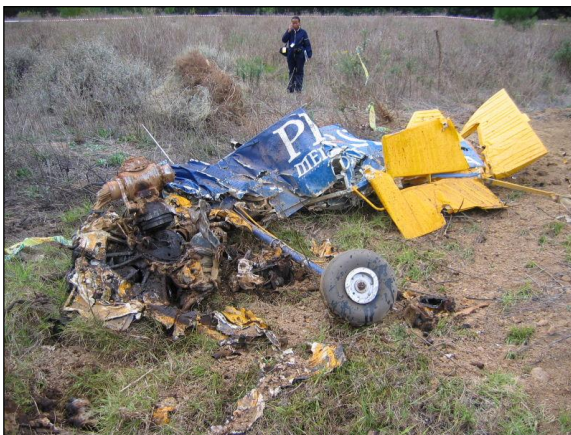
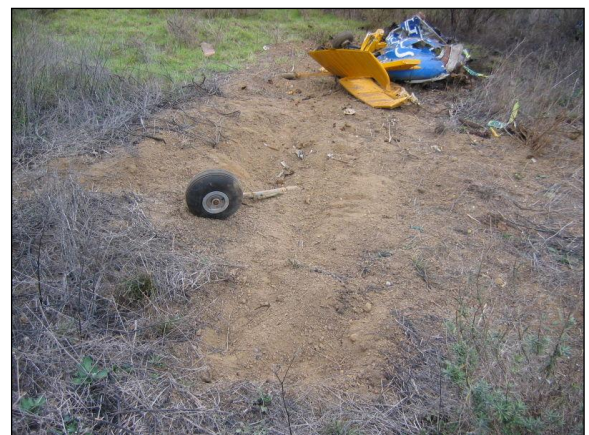
1.12.5 The remains of the fuselage are shown below.

1.12.6 The direction of impact of the fuselage was measured as 250°M. As is evident from the views above, ground impact was extremely severe and the fuselage was extensively distorted and compressed by the high impact forces.

1.12.7 The fuselage came to rest only 5 m from the initial impact point, which, combined with the degree of deformation, is evidence of a very steep impact angle. Various aircraft components were, however, still strewn up to 80 m from the initial impact point.

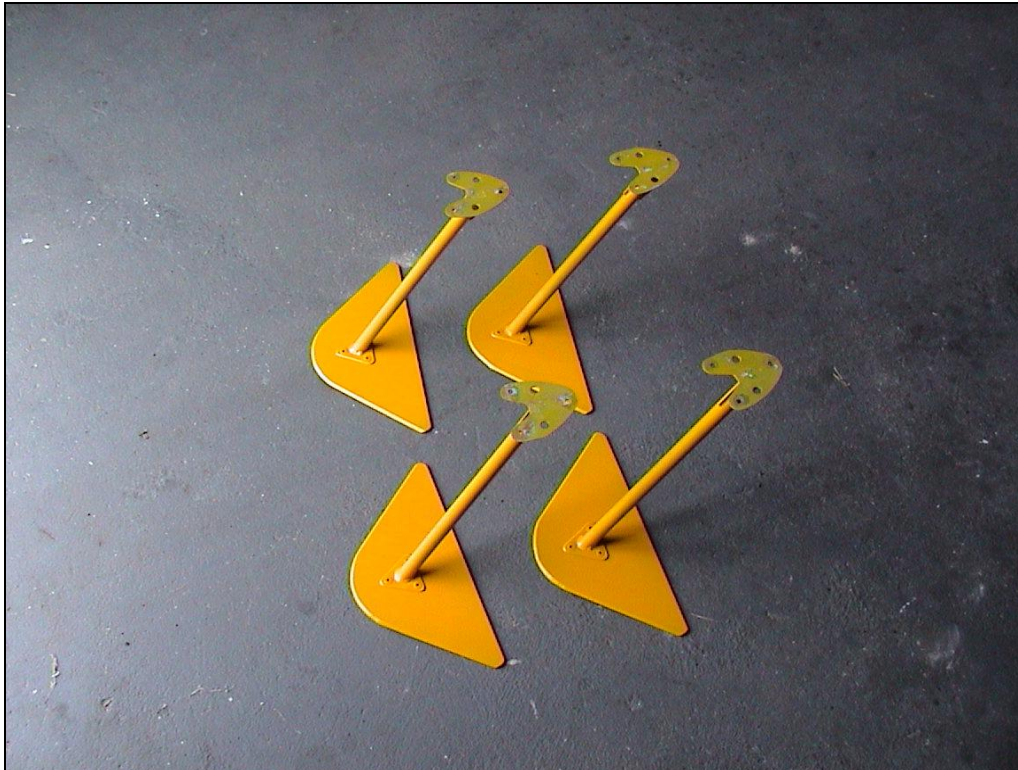
Aileron spades / mass balances later discovered in the hangar.

- 2.15 As mentioned earlier, it is evident that the aileron spades had been removed at some stage prior to the fateful flight. This meant that the mass balance of both ailerons would have been adversely affected in that their balancing weights were no longer present.

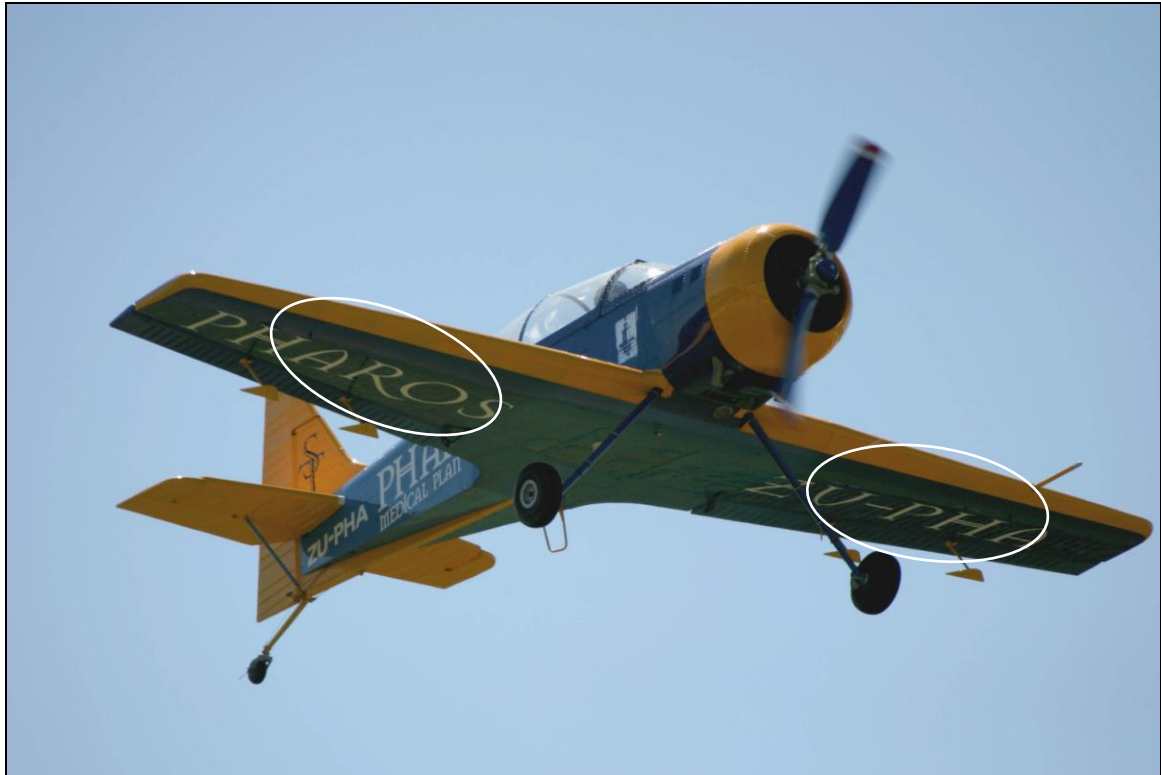
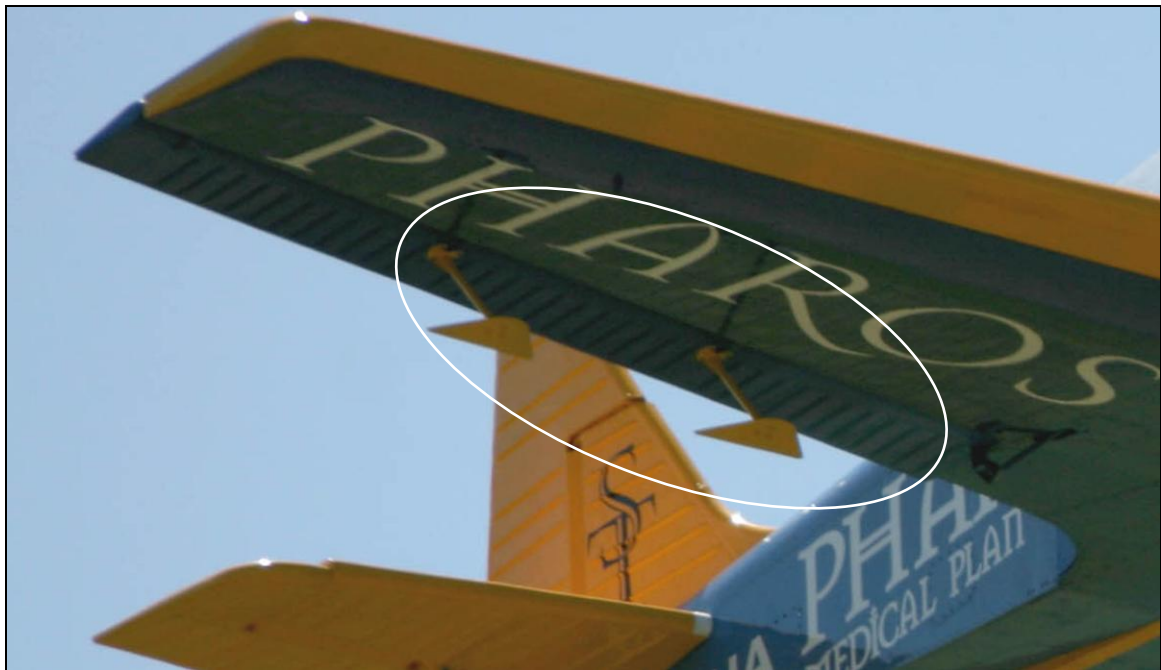
1.16.3 On the photographs below, the spades are clearly visible on the aircraft:.

- 1.16.4 The designer/maker of the aircraft was contacted and the issue regarding aileron flutter was discussed. The designer stated that the aileron spades served two purposes. The first was to relieve pilot loads on ailerons and the second was to serve as mass balances to the ailerons.
- 1.16.5 Flight without the aileron spades is strictly forbidden as the control surfaces would not be balanced, which would result in aileron flutter.
