TELEDYNE CONTINENTAL[®] AIRCRAFT ENGINE
SERVICE BULLETIN
 Compliance Will Enhance Safety

SB95-3B
TECHNICAL
PORTIONS ARE
FAA APPROVED

SUBJECT: ALTERNATOR/GENERATOR DRIVE COUPLING INSPECTION

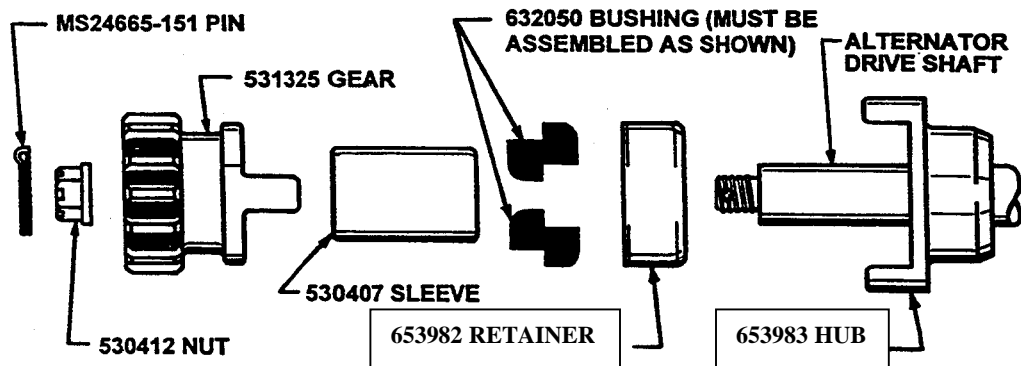
FIGURE 1

PURPOSE: Field reports and inspection of coupling assemblies have revealed parts that are severely worn or damaged. This bulletin requires inspection of affected alternator couplings to preclude the possibility of coupling failure.

5. Remove coupling assembly parts 531325 gear, P/N 530407 sleeve, P/N 632050 bushings and 653982 retainer. Do not remove P/N 653983 hub unless replacement is required. Discard bushings and retainer. Inspect nut, gear and sleeve for wear and damage and replace if necessary.

6. Install new replacement P/N 653982 retainer and two P/N 632050 bushings into the P/N 653983 hub on the alternator shaft. Bushings must be installed as indicated in Figure 1. Install P/N 530407 sleeve, P/N 531325 gear and P/N 530412 nut.

7. Clamp the alternator and hub assembly gear into the protected vise jaws only tight enough the torque the nut. Torque the P/N 530412 nut to 175 inch pounds. Torque may be increased to a maximum of 200 inch pounds to align castellated nut with the cotter pin hole. If alignment cannot be achieved with torque between 175 - 200 inch pounds, replace nut. Do not over or under torque! Install new P/N MS24665-151 cotter pin and secure in accordance with TCM Service Information Letter SIL93-15 or current revision as applicable.

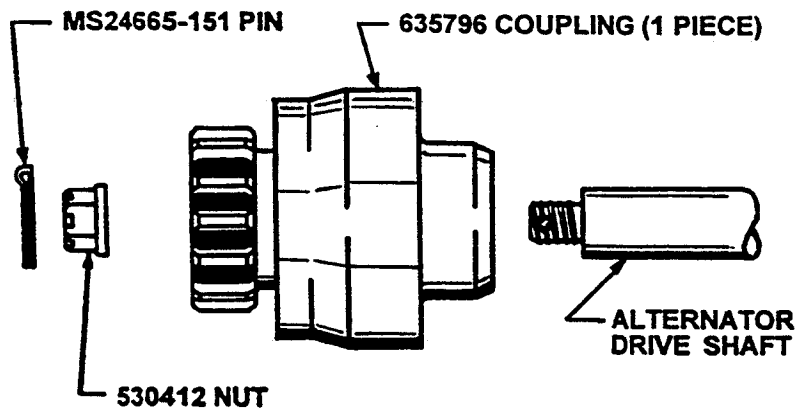
FIGURE 2

The P/N 635796 single piece coupling is designed to slip when abnormal torque is required to rotate the alternator/generator. This can prevent internal engine damage in the event of an alternator/generator seizure. The one piece coupling may be substituted for the coupling assembly shown in Figure 1.

Inspect the one piece coupling for shearing or tearing of the elastomeric (rubber) element. Replace coupling if damage is observed. The following test must be performed at engine overhaul or when slippage is suspected.

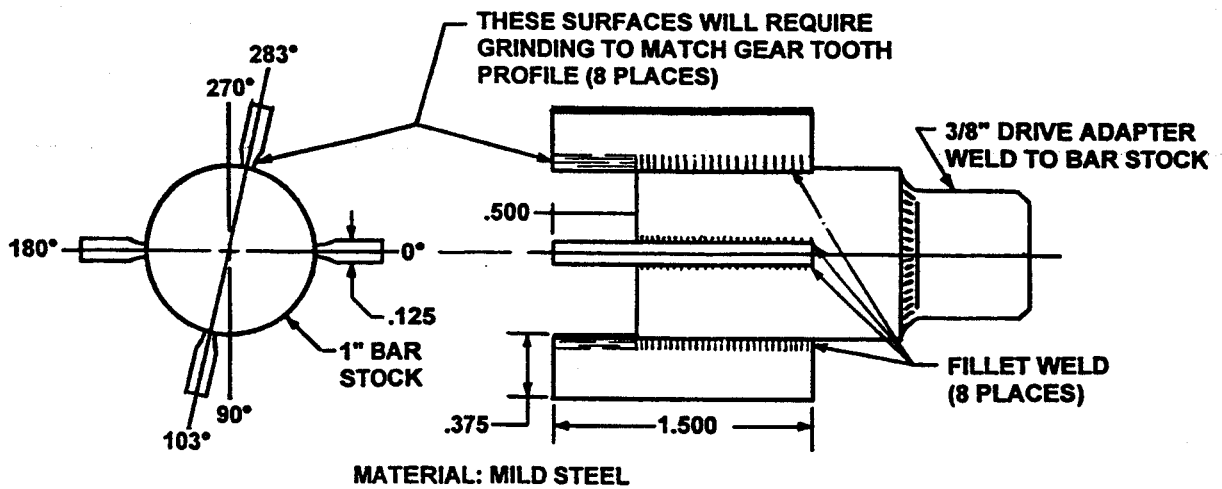
FIGURE 3

1. With the coupling removed from the alternator/generator, place the coupling body in the protected jaws of a vise.
2. Figure 3 provides necessary dimensions to produce a tool for checking coupling slippage torque.
3. Install the tool over the coupling gear and apply 100 inch pounds of torque. No slippage can occur at or below 100 inch pounds of torque. Replace couplings that fail this test.
4. Install serviceable or replacement couplings in accordance with section A, paragraphs 7, 8 and 9.
