Naumuk 6061-T6 Corrosion Problem

Sample: 6061-T6 sheet, 0.025"

Stored in dehumidified basement in contact with kraft paper on one side. I assume the sheet was in contact with a second sheet of aluminum on the rear side.

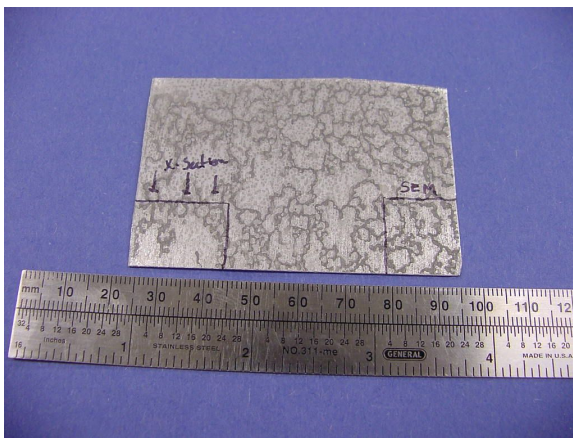
Figure 3: Two sections were removed from the sheet as indicated. The “x-section” portion was mounted in epoxy and polished to show the cross-section. The “SEM” portion was used for surface analysis in the scanning electron microscope.
