# SOUTH AFRICAN CIVIL AVIATION AUTHORITY

## ACCIDENT REPORT – EXECUTIVE SUMMARY

# AIRCRAFT ACCIDENT REPORT

**Name of Owner/Operator** : Sweidan G.  
**Manufacturer** : Interavia  
**Model** : I-3  
**Nationality** : South African  
**Registration Marks** : ZU-PHA  
**Place** : Vergelegen Estate, Somerset West  
**Date** : 5 April 2005  
**Time** : 1210Z

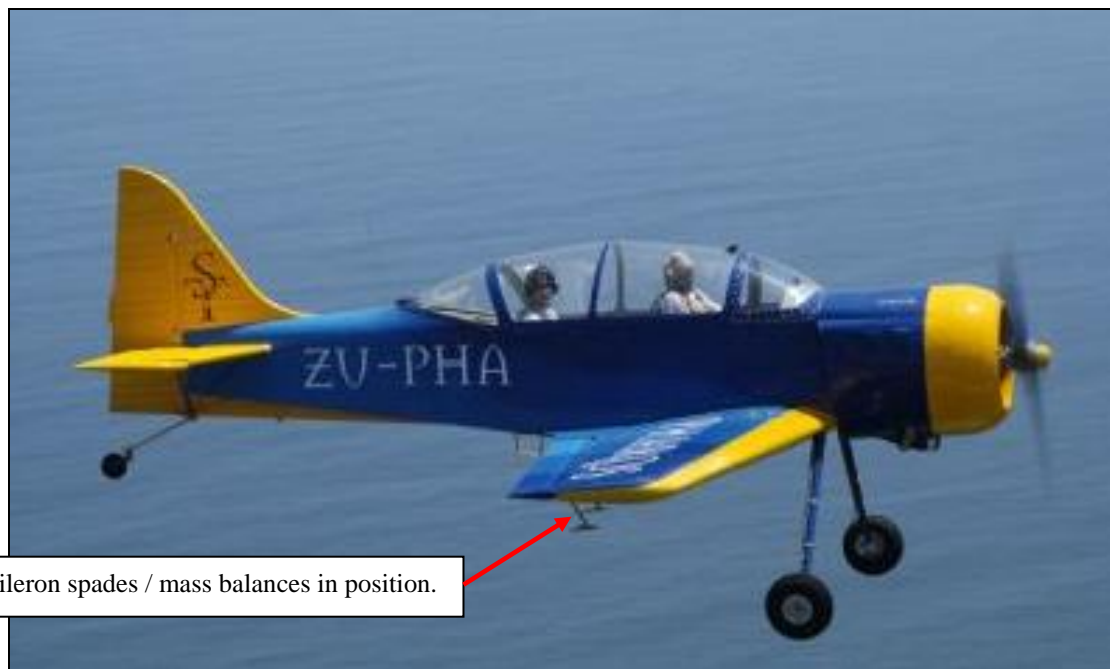
ZS-PHA photographed on a previous flight.

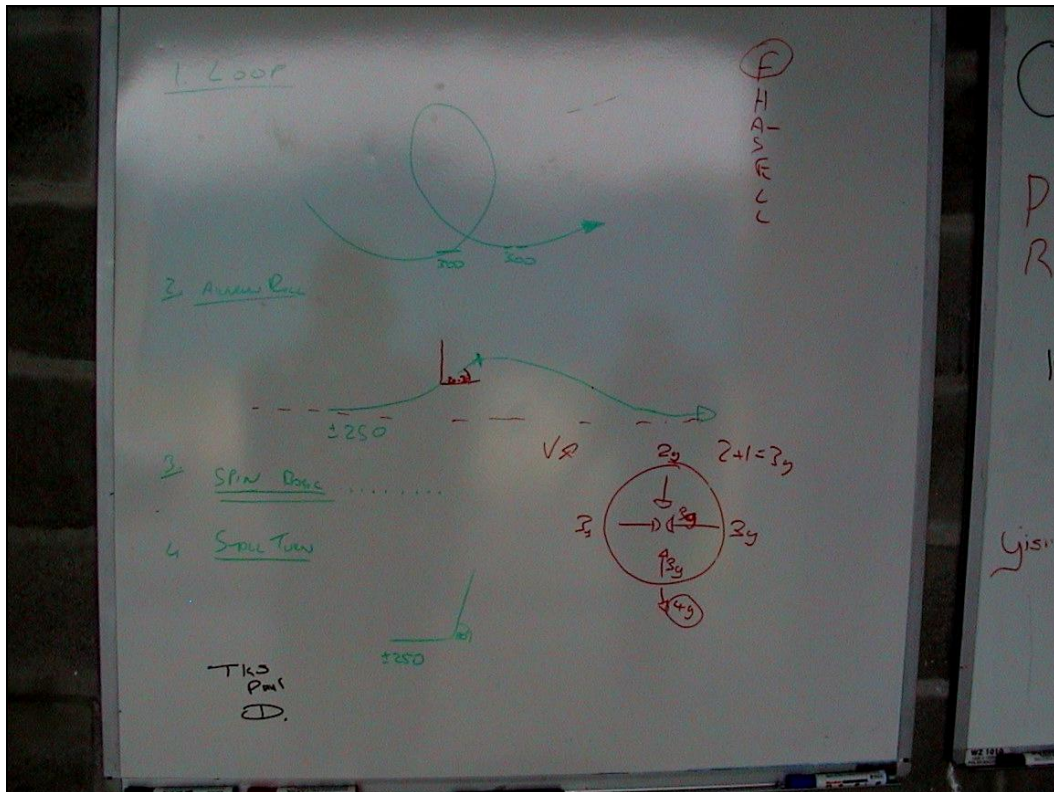
In the hangar where the aircraft had been parked and where the aileron spades were found, there was a white board describing a loop, aileron roll, spin roll and stall turn. The g-forces during a loop as well as the entry and exit speeds for a loop and a roll were also written down.

The board in the hangar showing the manoeuvres.

- 1.18.1.6 The entry and exit speeds for the loop were shown as 300 km/h. For the aileron roll, they were given as 250 km/h.
- 1.18.1.7 Inspection of the wreckage site uncovered a small piece of paper on which several manoeuvres were written. These were:
