REAR CHANNEL 6W7-1

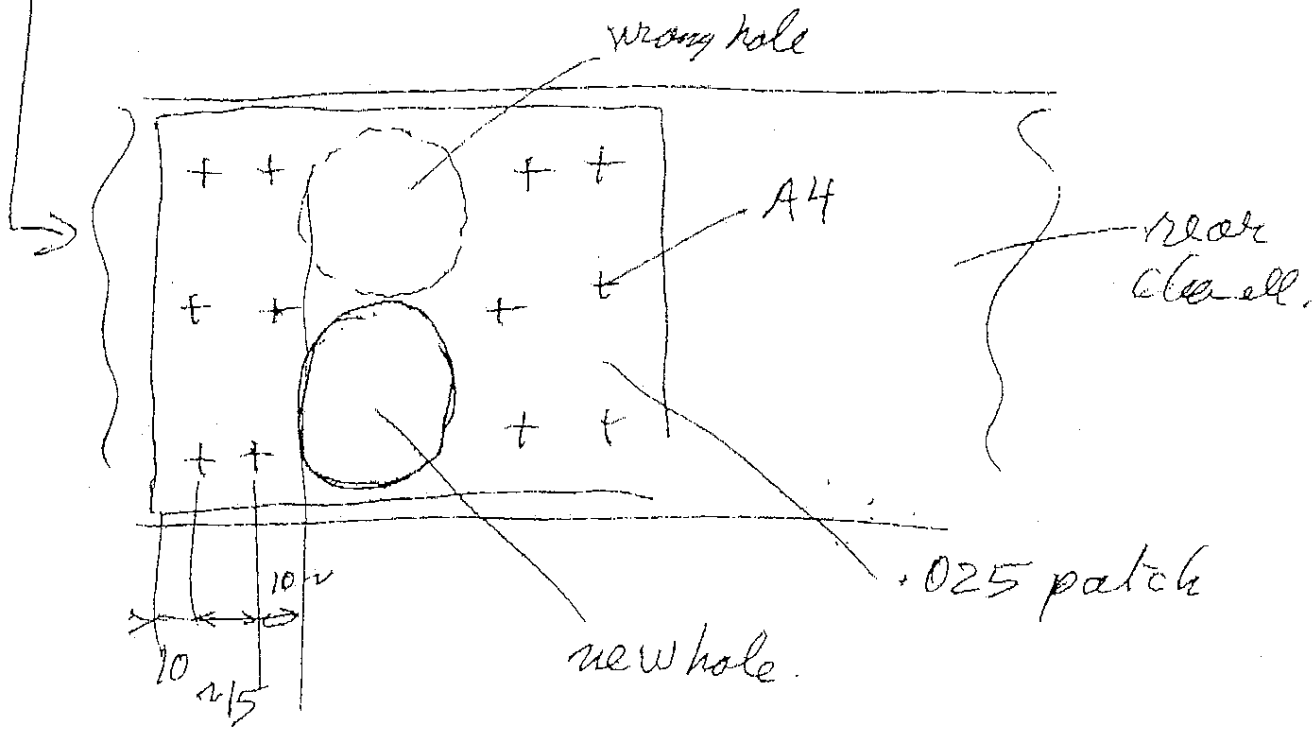
- > When I cut the hole for the aileron rod, the wing
- > was upside down. As a result, I have a beautifully finished hole near
- > the top of the rear spar. Is it possible to patch this without losing
- > wing integrity?
